The pages to follow contain your TOTAL HOME INSPECTION report, which is based on observations made while conducting an inspection of 1 [REDACTED]

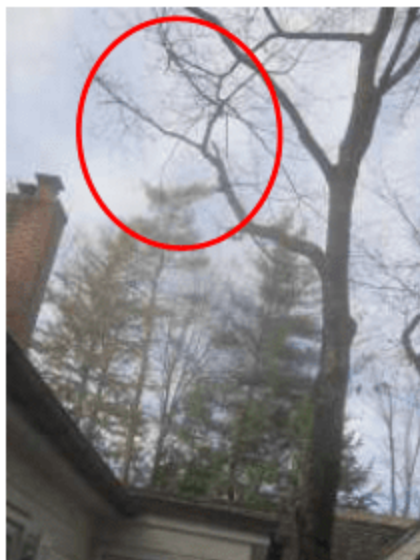
There are branches overhanging the roof and gutter system (see photo left). By trimming or removing them, you will likely reduce roofing, gutter and siding maintenance and repair and you will also remove a potential bridge for animals.

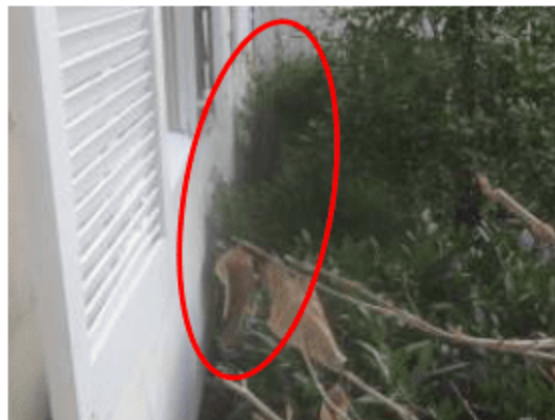
dead. In the interim, some of the shrubbery needs minor pruning (see photo right for example area). Trimming the plantings away from the foundation and building to afford a minimum of twelve inches of clearance between the shrubs and exterior cladding will help prevent moisture from being trapped against the structure, potentially promoting rot on and beneath vulnerable exterior components.

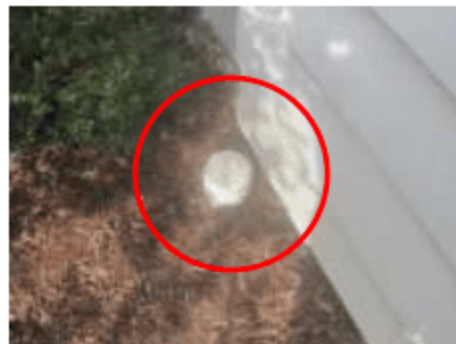
A capped, white, PVC pipe was observed in the front left center flower bed (see photo right). Our inspector was unable to definitively determine a purpose for the pipe (sewer line clean out access or a planned in-ground receptacle for a gutter system leader?) therefore we recommend that you inquire with the seller as to its purpose.

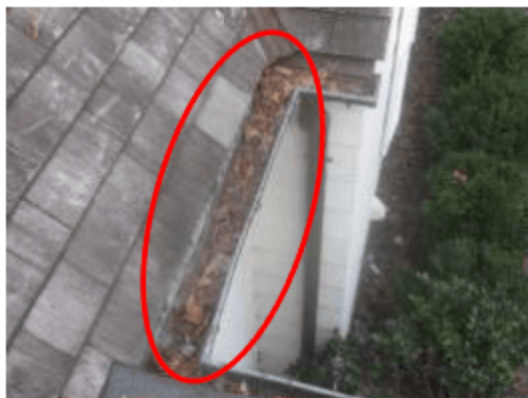
Portions of the guttering system require cleaning now and at least every spring and multiple times during the fall in the future (see photo left of example area). If these gutters are not cleaned, you will experience ant infestation and a general rotting condition.

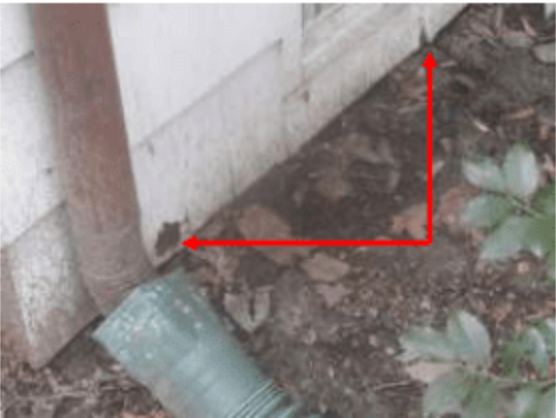
There were places around the house where rot or the onset of wood rot was observed, for example at the lower course of shingles at the rear center part of the house (see photo right of example shingles). This and all rotted or potentially rotted wood should be removed, and the sub-surfaces should be repaired as necessary. When the sub-surfaces are repaired, new wood should be installed, caulked and painted. Potentially rotting wood that is not repaired remains an invitation to insect infestation. When the sub-surfaces are exposed, if any insect activity is found, it should be treated as necessary at that time.

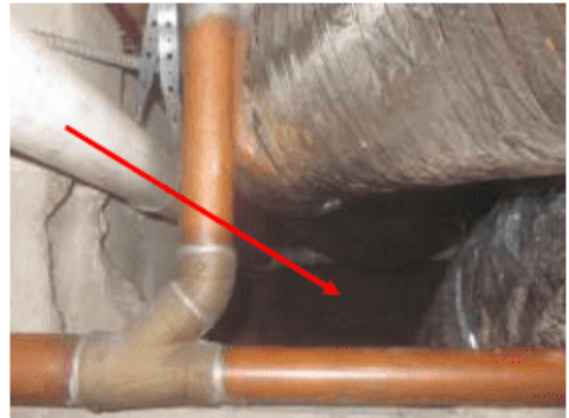
This house had a crawl space at the rear left part of the house that we were unable to enter due to the small portal being blocked by ductwork and waste pipes (see photo right). As a result, we could not inspect important structural and mechanical conditions within that area or provide any definitive findings about this area this report. We recommend that this area be made accessible and an inspection by TOTAL HOME INSPECTION and a licensed pest control company be arranged prior to your closing.

To help eliminate an inviting environment for wood destroying insects, the wood, detritus and debris should be removed from the crawl space areas.

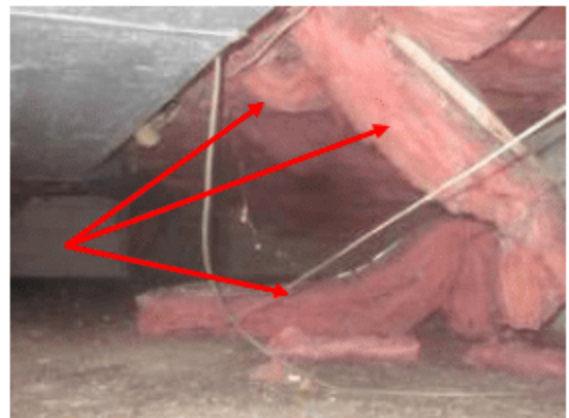
The sagging, fallen, displaced and missing sections of insulation beneath the first floor sub flooring visible in the crawl space areas (see photo right for example area) should be reinstalled or replaced as required to help improve energy efficiency and comfort.

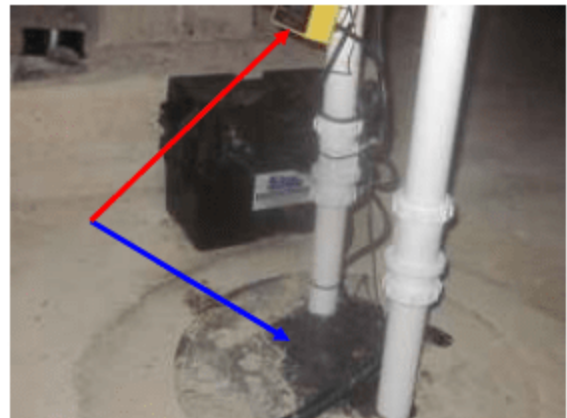
We were unable to operate the sump pump because it was located beneath a sealed cover (see photo right – blue arrow). Its operation could only be verified by the test button on the pump piping (see photo right – red arrow). Sump pumps should be kept in good working order and tested several times a year. We recommend that you maintain the battery operated back-up system installed for the sump pump to help ensure its operation during a power outage.

The sump pump appears to discharge into the municipal sewer system, which is not allowed by most municipalities. The sump pump should discharge into a storm drain or onto the ground surface as far away from the building as practical.

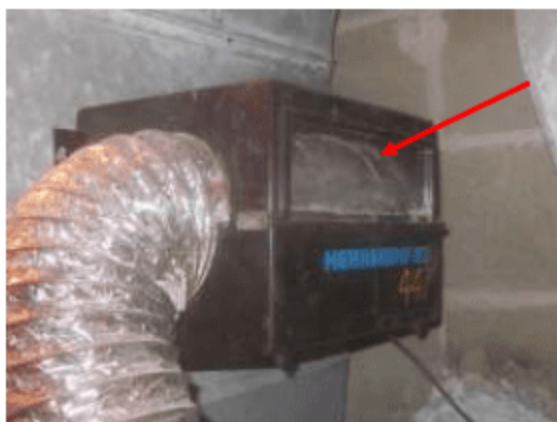
The humidifier (see photo left) was not operational at the time of inspection. If you intend to use this unit, request it be put in good working condition. Humidifiers are prone to leaking. If leaking occurs, it should be serviced promptly to prevent damage to the heat exchanger and/or to the ductwork. Humidifiers should be serviced in accordance with the manufacturer's recommended procedure. We do not recommend the use of this type of humidifier.

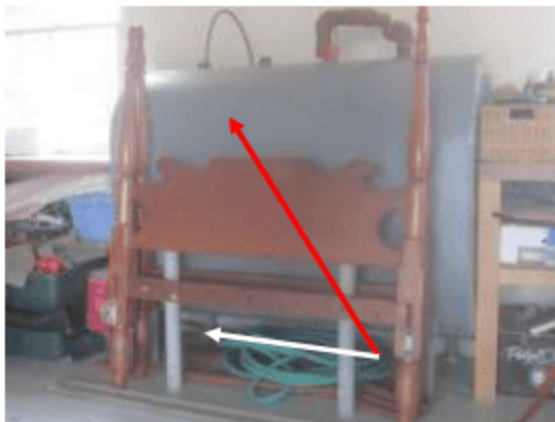
The visible areas of the 15-year old, 275-gallon, oil storage tank were in generally acceptable condition (see photo left red arrow). Oil storage tanks have an average useful life expectancy of 30-40 years but the life expectancy can be affected significantly by the environment around the tank.

The main fuel (#2 heating oil) shut off valve is located in the garage at the base of the aforementioned 275-gallon oil storage tank (see photo left – white arrow).

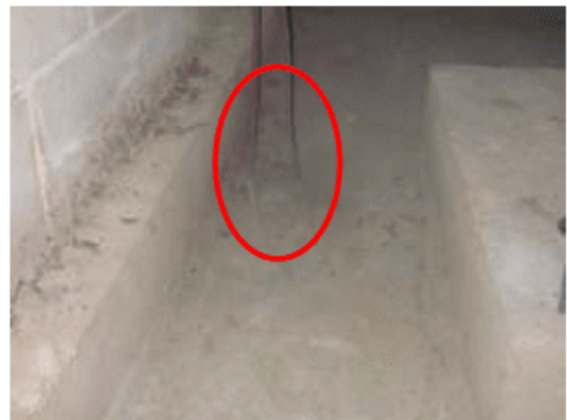
The oil supply pipes are covered with concrete in the garage and they run below the concrete floor in the crawl space (see photo right for example area), preventing evaluation of the oil supply pipes. The copper pipes are likely to be adversely affected by their contact with the concrete. It should be noted that oil could leak from these pipes below the concrete. We recommend that you have your oil supplier re-route the oil lines as required to remedy this condition and that the pipes be encased in protective sleeves to help prevent damage to the pipes.

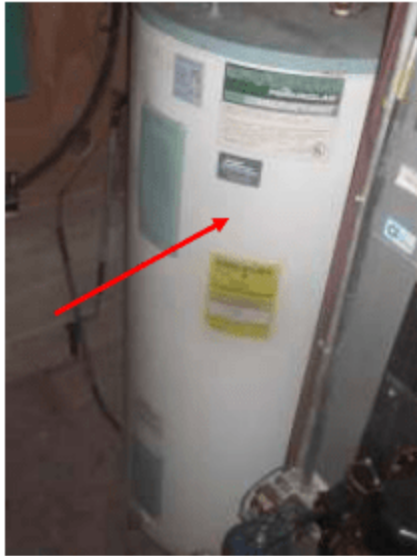
The water is heated by an independent, 80-gallon, electric, A. O. Smith brand, water heater (serial # MG88-0025599-913 – see photo below left) with a recovery rate of approximately 80 gallons per hour. The hot water supply system was evaluated and found to provide adequate amounts of hot water to all fixtures tested, at the time of this inspection.

According to our inspector's thermometer, the undiluted hot water temperature was approximately 133.6 degrees Fahrenheit. It is recommended that the undiluted hot water temperature remain between 120 degrees Fahrenheit and 125 degrees Fahrenheit to prevent scalding and for your comfort. Make the appropriate adjustments for safety purposes.

The water heater appears to be 23 years old. Water heaters that service municipal water supplies and that are properly maintained have an average useful life expectancy of 10-15 years. These units deteriorate from the inside out. We have no way of determining the interior condition of the water heater. Your plans should include replacing the water heater before it fails.

We recommend installing a pan and a drain under the water heater to prevent damage caused by a system failure or the discharge from the safety device.

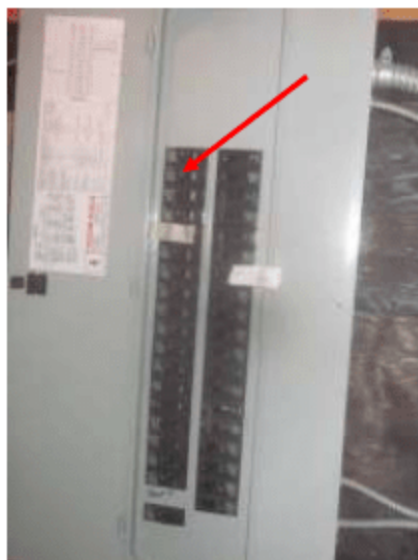
There is a 20-ampere electrical circuit breaker in the main electric panel (2nd breaker down on the left side of the panel – see photo above center) that has not been wired correctly. The correct size breaker must be fitted onto the correct size wire to prevent overheating of the wire. The 20-ampere breaker should be fitted with a 12 gauge wire for your safety. Have a qualified, licensed electrical contractor make the necessary corrections prior to your closing.

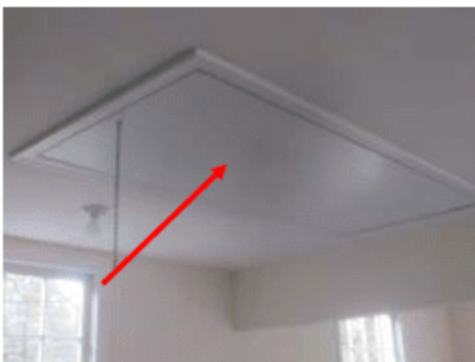
The garage storage loft is accessed by a pull-down staircase in the garage (see photo left). It has been framed for lightweight storage only. Do not store any heavy objects in this loft.

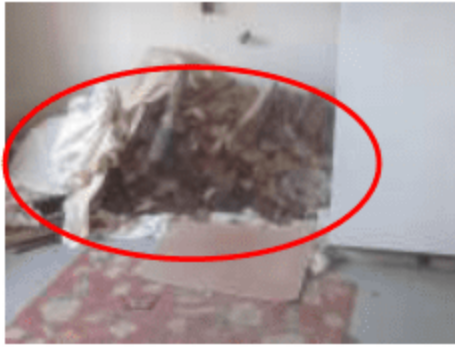
We recommend that the firewood be removed from the garage (see example of firewood in the garage in photo left). It should be stored as far away from the structure as practical to help control the moisture level in the garage and to help prevent and inviting environment for wood destroying insects and rodents.

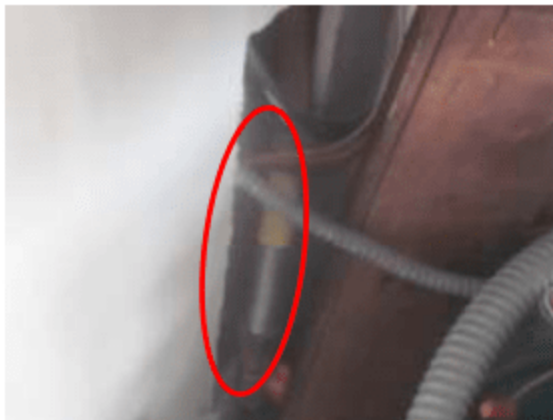
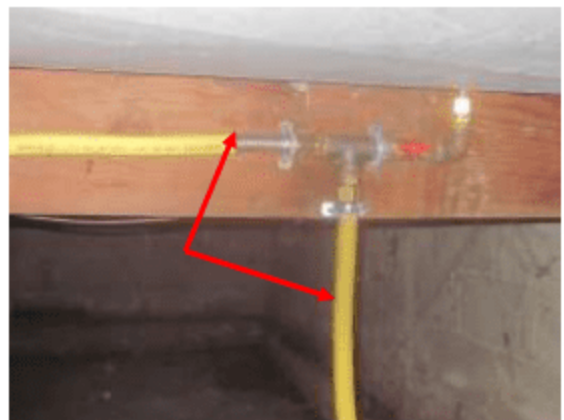
Corrugated stainless steel tubing (CSST) was observed in the crawl space (see photo right) and in the garage (see photo left), apparently servicing the

propane-fired range top burners and the left side barbeque. This type of flexible tubing has thin walls and would be vulnerable to splitting, in the event of the house incurring a lightning strike, for example. For more information regarding the safety of this type of product and recommendations
