The pages to follow contain your TOTAL HOME INSPECTION report, which is based on observations made while conducting an inspection of 1 [REDACTED]

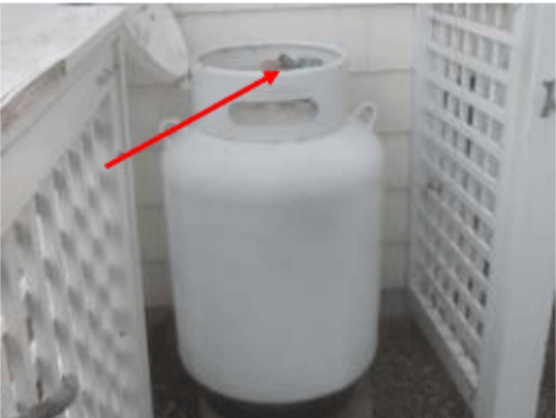
A propane tank was located at the rear left side of the house. The propane gas (LPG) shut off valve is located under the top cover of the tank (see photo right).

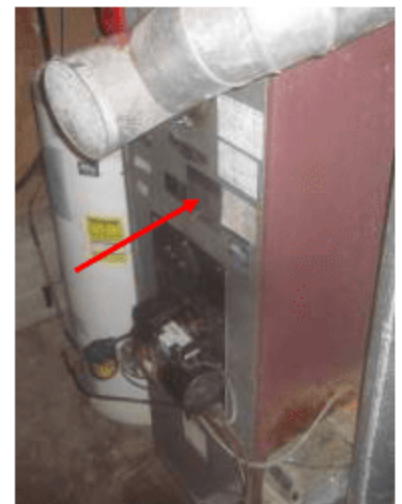
Consistent with the information provided by the Standard Oil technician who evaluated the system, the heating plant is an oil-fired, steel, Thermo Pride brand furnace (serial # 42H2911/ model # OT16-125 – see photo right). The furnace fired satisfactorily at the time of this inspection. It should be cleaned, including flue passages, and all components adjusted to operate at peak performance. The fan unit and blades should be vacuumed and lubricated, as required, and the belts adjusted or replaced. All safety devices should be checked. The heat exchanger should be inspected for cracks and/or leaks prior to your closing (the heat exchanger can only be totally inspected by dismantling the furnace). If it cannot be verified that this furnace and

its components have been serviced and cleaned within the past year, arrangements should be made for that servicing.

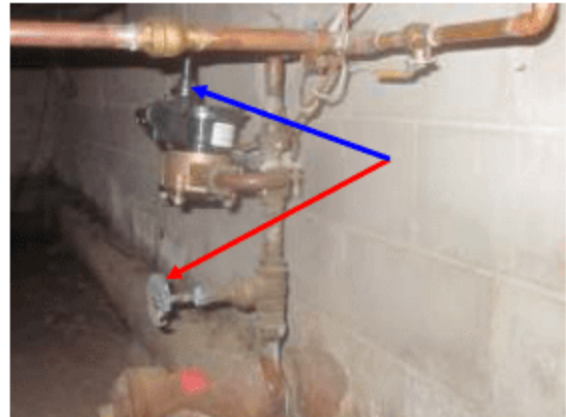
The main water supply piping is copper. The main shut-off valve is located in the crawl space (see photo right – red arrow).

A "remote" meter reader has been installed on the water meter in the crawl space (see photo right – blue arrow), which should mean that the water meter should be able to be read remotely from the exterior of the house.

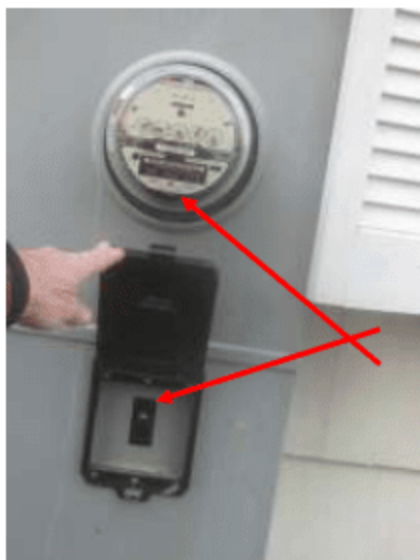
The 200-ampere, 120/240-volt electrical system enters the building via overhead cables. The electric meter and main service disconnect switch are located on the exterior of the building (see photo below left). The primary panelboard (load center) is located in the basement/utility room. (see photo below center). There is also a secondary panelboard (sub panel) located in the basement/utility room. The main distribution panel has been fed with aluminum feeders. The sub panel has been fed with copper. Where visible the distribution conductors (wires) are copper, armored cable (AC/BX) and copper, non-metallic sheathed cable (NM/Romex) type conductors (wires). They were in generally acceptable condition. All circuit breakers in the electrical panel should be properly labeled for your safety and for your convenience. The electrical breaker switches in the panel should be tested on an annual basis. The system has been grounded to the incoming water pipe.

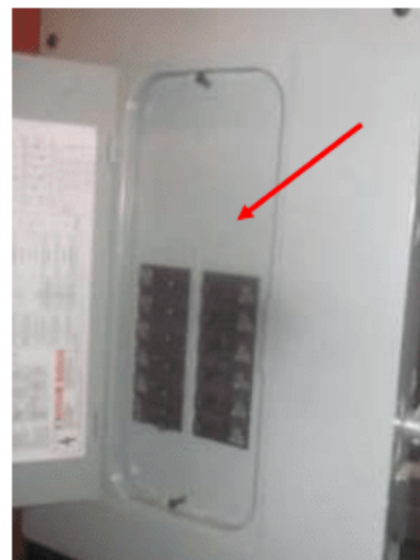
There is a 20-ampere electrical circuit breaker in the main electric panel (2nd breaker down on the left side of the panel – see photo above center) that has not been wired correctly. The correct size breaker must be fitted onto the correct size wire to prevent overheating of the wire. The 20-ampere breaker should be fitted with a 12 gauge wire for your safety. Have a qualified, licensed electrical contractor make the necessary corrections prior to your closing.

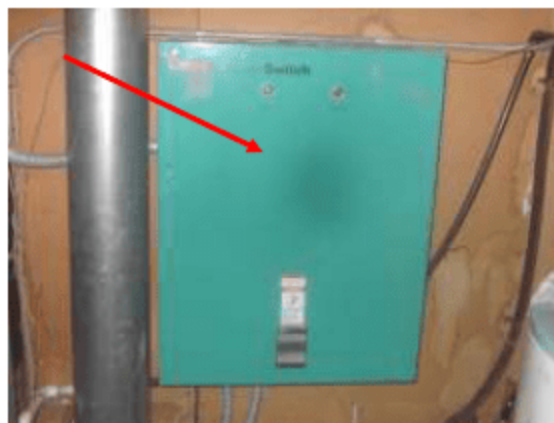
This house has been fitted with a generator system in case of a power outage (see photo right of part of the interior components located in the basement/utility room). Evaluating generator systems is beyond the scope of the standard home inspection we performed for you, therefore no evaluation of the system is included in this report. Inquire with the seller or a qualified contractor that specializes in generators regarding the proper operation of this system. We also recommend that you inquire with the seller as to whether the generator is included in the purchase price of the house.

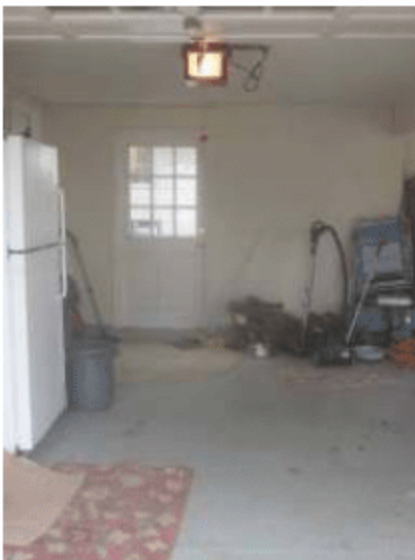
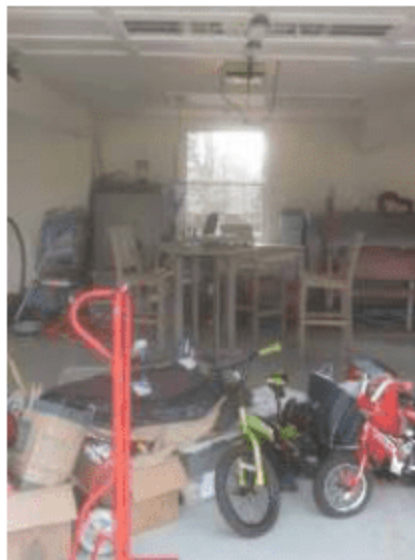
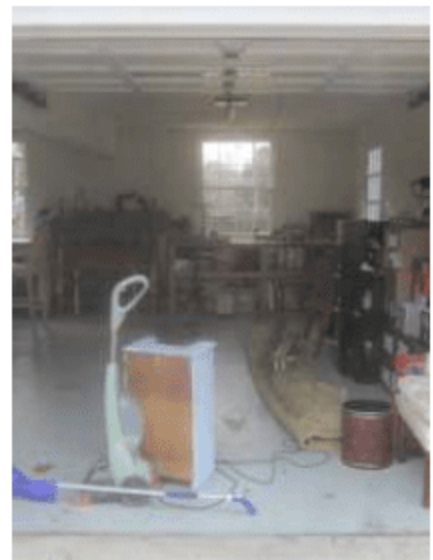
The three-car garage has a concrete floor. The walls and ceiling are gypsum board. Due the materials being stored in the garage, we were unable to inspect all parts of its interior surfaces. Where visible (see photos below left, below center and below right), they were generally in acceptable condition with the observations to follow to be taken into account and corrections made as required.
